Field Performance
Evaluation of
Polymer Coated
CSP Structures in

N E W Y O R K

**NATIONAL CORRUGATED
STEEL PIPE ASSOCIATION**

March 2002

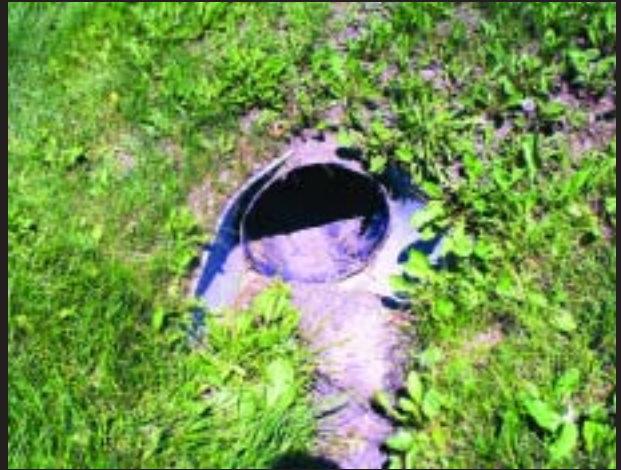
155/1101/3064

155/1101/3064. This pipe is a 48-inch cross drain underneath a two-lane road (Rte 155). The pipe is constructed of four sections with polymer-coated bands. Two of the sections had field cut ends that resulted in a mismatch at one joint. There was approximately 6 to 12 inches of flowing water at the time of our inspection. There was heavy bedload (rocks) in the invert of the pipe.

COATING CONDITION. The polymer coating was generally in excellent condition. In some locations along the cut edges, the polymer coating could be lifted from the galvanizing for approximately ¼ inch. There was no significant metal loss at these edges. At all other locations the coating was well bonded. Where the field cuts were made, there was metal saw filings embedded in the polymer coating that exhibited corrosion. This should not be mistaken for corrosion of the substrate. The asphalt was well bonded to the polymer.

At the galvanized end section, all of the galvanizing was consumed and there was corrosion below the waterline. Above the waterline, the galvanized was in tact on the end sections.

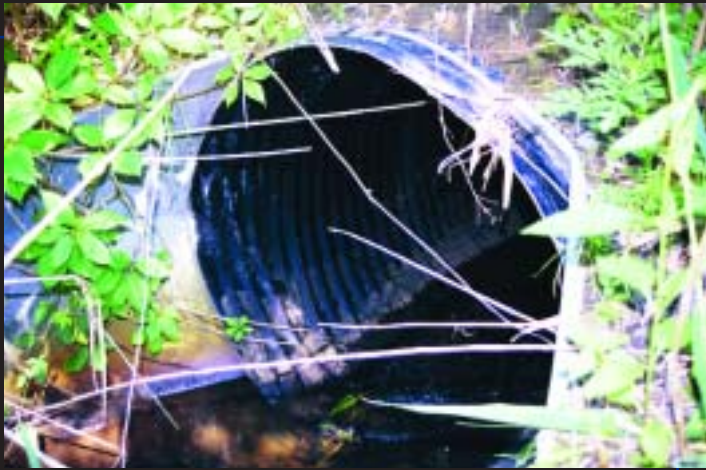
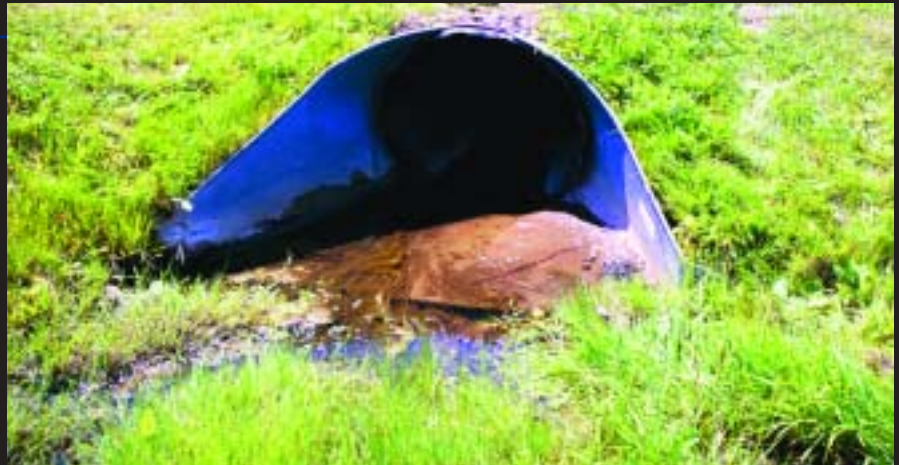
155/1101/3078

155/1101/3078. This 42-inch by 29-inch pipe arch is a cross drain underneath a two-lane road (Rte 155) immediately adjacent to Bison Road. A concrete drain connects two pipe sections. All joints were tight and exhibited no signs of leakage. There was a trickle flow of water a few inches deep at the time of our inspection.

COATING CONDITION. The polymer coating was generally in excellent condition. In some locations along the cut edges, the polymer coating could be lifted from the galvanizing for approximately ¼ inch. At the extreme bottom of the invert on one end, the coating could be lifted back as far as one inch. There was no significant metal loss at these edges. At all other locations the coating was well bonded. The asphalt was well bonded to the polymer. No metal was exposed in the invert.

The galvanized end section had some localized corrosion at the waterline, but was in generally good condition.

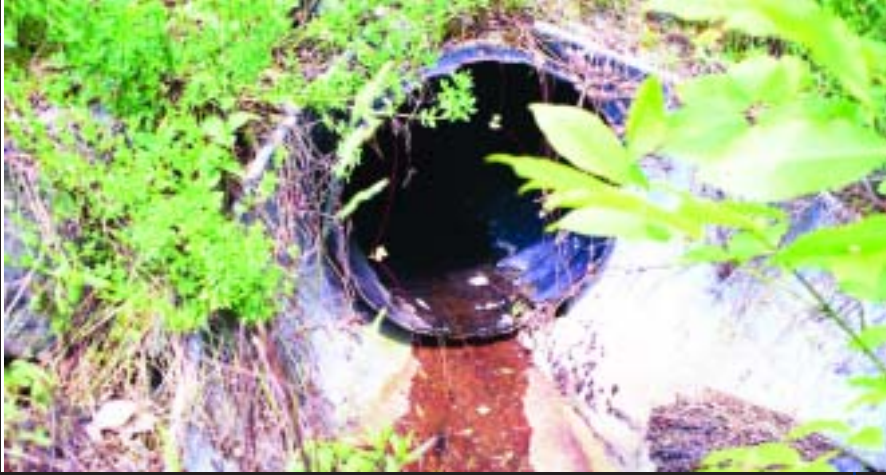
30/2206/1714

30/2206/1714. This site includes two, 30-inch pipes. One pipe is a cross drain underneath a two-lane road (Rte 30). The second pipe is side drain on the east side of the road which diverts water around an existing property. The two pipes are connected at a concrete collection basin. The pipes are constructed of multiple sections. All joints appear to be tight, exhibiting no signs of leakage. There was water flow at the time of our inspection. There was approximately 9 inches of gravel in the invert of the pipe.

COATING CONDITION. The polymer coating was generally in excellent condition. In some locations along the cut edges, the polymer coating could be lifted from the galvanizing for approximately ¼ inch. There was no significant metal loss at these edges. At all other locations the coating was well bonded. On one side of the waterline at the outlet of the side drain, the coating could be lifted back as far as one inch. The asphalt was well bonded to the polymer.

The galvanized end section at the outlet of the side drain was perforated just above the waterline. This occurred immediately adjacent to the location where the polymer coating could be lifted up to one inch.

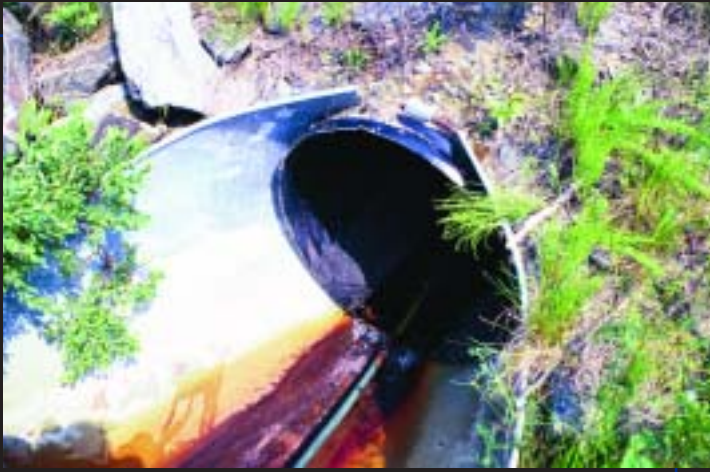
30/2206/1715

30/2206/1715. This pipe is a 30-inch diameter cross drain underneath a two-lane road (Rte 30). The pipe is constructed of multiple sections with polymer-coated bands. All joints were tight and exhibited no signs of leakage. There was a trickle flow of water at the time of our inspection.

COATING CONDITION. The polymer coating was generally in excellent condition. In some locations along the cut edges, the polymer coating could be lifted from the galvanizing for approximately ¼ inch. There was no significant metal loss at these edges. At all other locations the coating was well bonded. The asphalt was well bonded to the polymer. No metal was exposed in the invert.

The galvanized end section had rust staining and some rusting steel in the invert. The staining made the extent of corrosion look slightly worse.

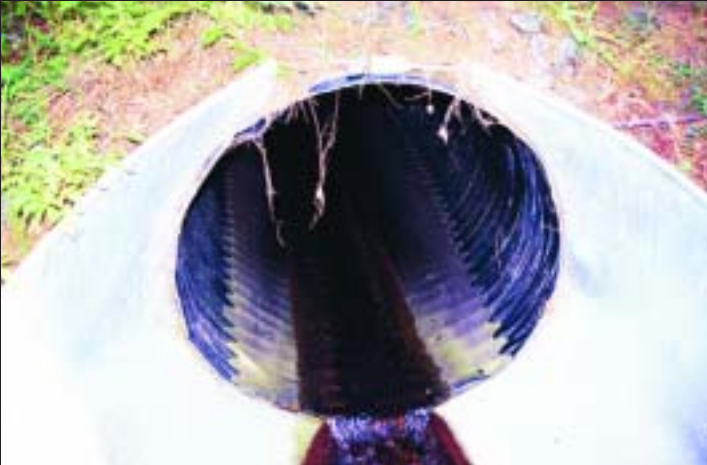
30/2206/1710

30/2206/1710. This pipe is a 36-inch cross drain underneath a two-lane road (Rte 30). The pipe includes a polymer-coated extension on either end of a concrete pipe. The length of the extension is nominally 6 feet on the west side and 4 feet on the east side. Both joints were tight and exhibited no signs of leakage. The pipe was installed on a steep slope and there was flowing water at the time of our inspection.

COATING CONDITION. The concrete pipe had approximately 1 inch of wear in the invert, exposing aggregate. The polymer coating was generally in excellent condition. In some locations along the cut edges, the polymer coating could be lifted from the galvanizing for approximately ¼ inch. There was no significant metal loss at these edges. At all other locations the coating was well bonded. The asphalt was well bonded to the polymer. No metal was exposed in the invert.

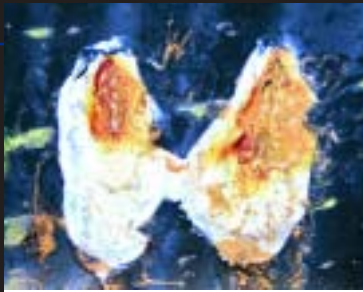
30/2206/1296

- The polymer coated CSP has performed very well at 19 of the 20 sites inspected. One installation showed signs of blistering over less than one percent of the pipe and is considered an anomaly. (See discussion Site 30/2206/1296)

30/2206/1296. This pipe is a 48-inch equalizer/cross drain underneath a two-lane road (route 30) that connects two bogs. At the time of the inspection, there was 10 inches of water flowing toward the east. The pipe is constructed of six sections with polymer-coated bands. All joints were tight and exhibited no signs of leakage.

COATING CONDITION. The galvanized end sections were severely rusted with some perforations. Several blisters of varying sizes were noted in the polymer coating. They appeared to be worse at the typical water line on the south wall of the first section of pipe on the east, but they were noted at other locations. When the blistered polymer was removed, there were distinct slits up to three inches long, with adjacent corrosion occurring from the edges. The metal appeared to have been cut or gauged through to the polymer from the outside, though the inside film was intact. Based on the linear shape and distinctiveness of the steel loss, we do not believe this was due to corrosion. The steel must have been cut through the majority of its thickness prior to installation. Further investigation would be required to determine exactly what happened. It should also be noted that the environmental conditions at this site are most likely more aggressive than the data suggests. The soil sample was retrieved from the fill slope and not indicative of the corrosive soils behind the blisters. Also, bogs such as this tend to have lower pH and resistivity readings. There was active corrosion of the steel at the defects. It is of interest that this pipe is the only pipe to have an electrochemical potential less active than -600mV (-563mV), which is indicative of steel corrosion.
