Field Performance
Evaluation of
Polymer Coated
CSP Structures in

W I S C O N S I N

**NATIONAL CORRUGATED
STEEL PIPE ASSOCIATION**

March 2002

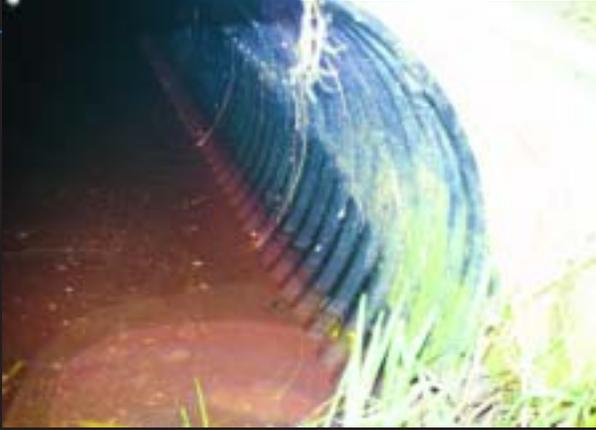
^ Polymer Coated

Polymer Coated. One of the test pipes was polymer coated and riveted construction. The pipe had several inches of standing water and approximately one inch of silt at the time of the inspection. The polymer coating was well adhered and pliable. The coating thickness was 12 mils (polymer plus galvanized) both internal and external. Approximately ¼ inch of polymer could be lifted at some locations along the edge of pipe. Near the rivets, no polymer delamination was evident.

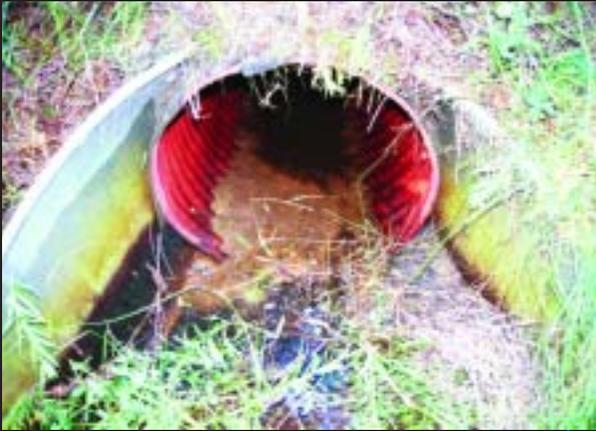
^ Epoxy Coated

Epoxy Coated. One pipe at this site was spiral weld construction with an epoxy coating applied. The pipe had a few inches of heavily silted standing water at the time of the inspection. The coating thickness was measured between 22 to 26 mils. From the east end the coating was observed to be in good condition, including over the welds. The epoxy could only be chipped off of ¼ inch at the cut edge. The west end of the pipe showed coating damage, with the bottom 270 degrees of coating missing. Where the coating is missing, there is active corrosion but no perforation.

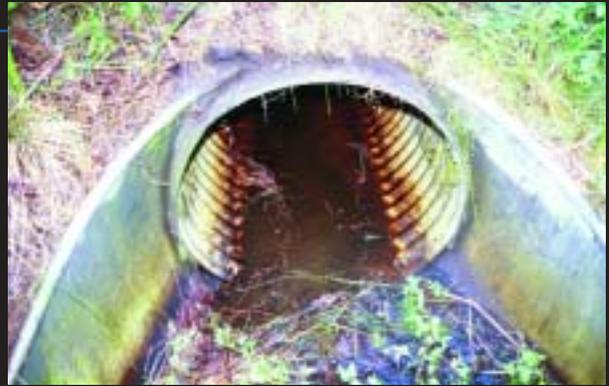
^ Aluminum

Aluminum. One pipe was constructed of riveted aluminum. The pipe had several inches of standing water and approximately one inch of silt at the time of the inspection. Staining and very light pitting (not practicably measurable in the field) was present on pipe interior, especially in the invert.

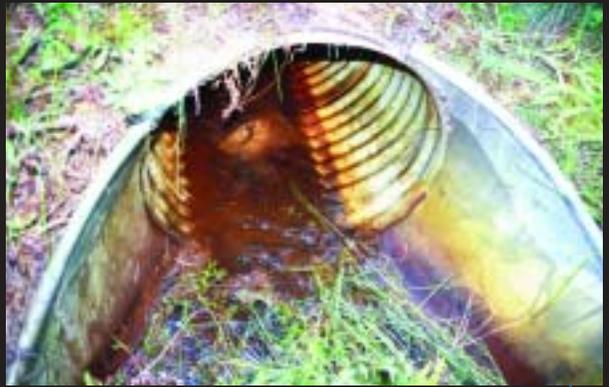
^ Aluminum Coated Type 2

Aluminum Coated Type 2. One pipe at this location was helically fabricated from aluminum coated material with a galvanized end section. There was several inches of water saturated mud in the invert, possibly the cause of the higher observed water pH. The lockseam had some minor corrosion, otherwise the pipe appeared to be in good condition.

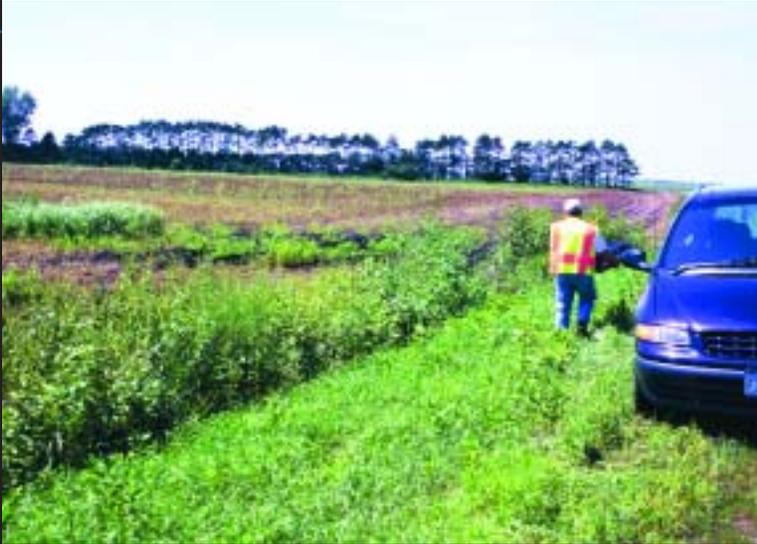
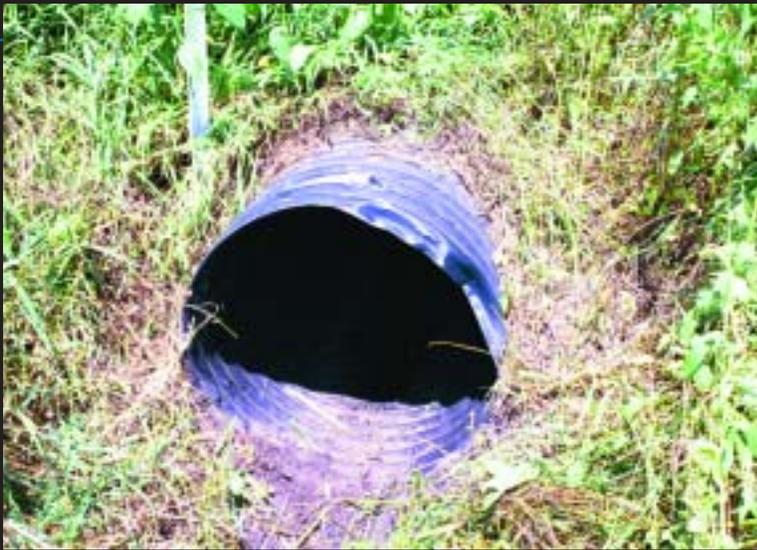
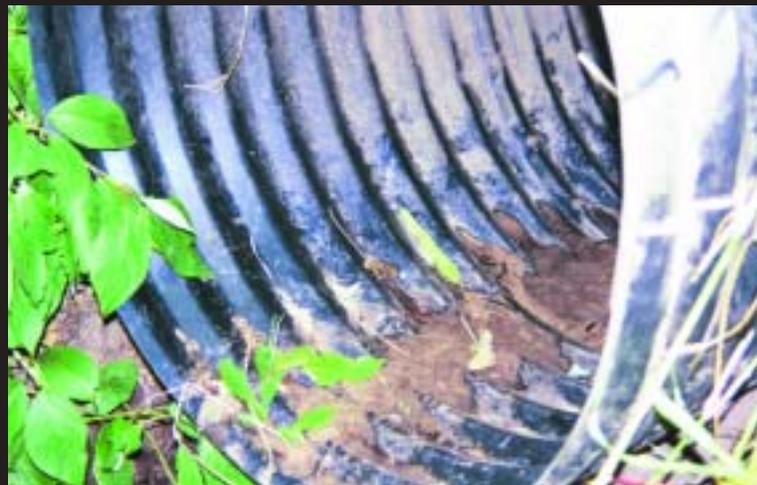
At this location there was one, 30-inch diameter polymer coated pipe. The pipe was installed in 1974 and was 27 years old at the time of our inspection. The pipe carried agricultural runoff from a farm on the south end to a small, wooded pond on the north end of the pipe. Thickness measurements revealed that the polymer coating was 10 mils inside and 3 mils outside. On the interior of the southern exposed end, a triangle of polymer coating at the crown tapering back to the exterior cut edge of the pipe was delaminated (approximately 2 square feet). This area was slightly smaller than the exposed end. The polymer was tightly adhered at the edges of the delaminated area. There was no corrosion under the film. The polymer on the remainder of the pipe was well adhered.

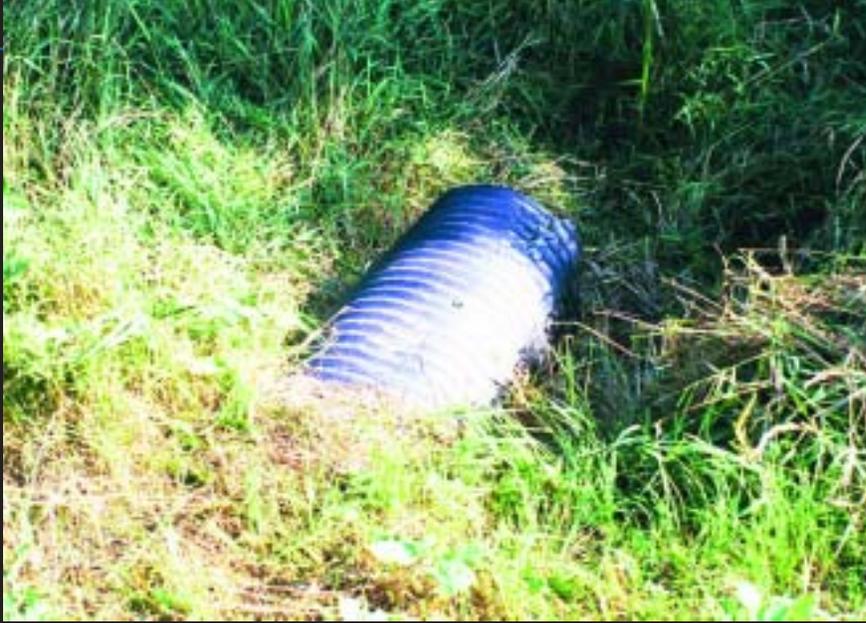
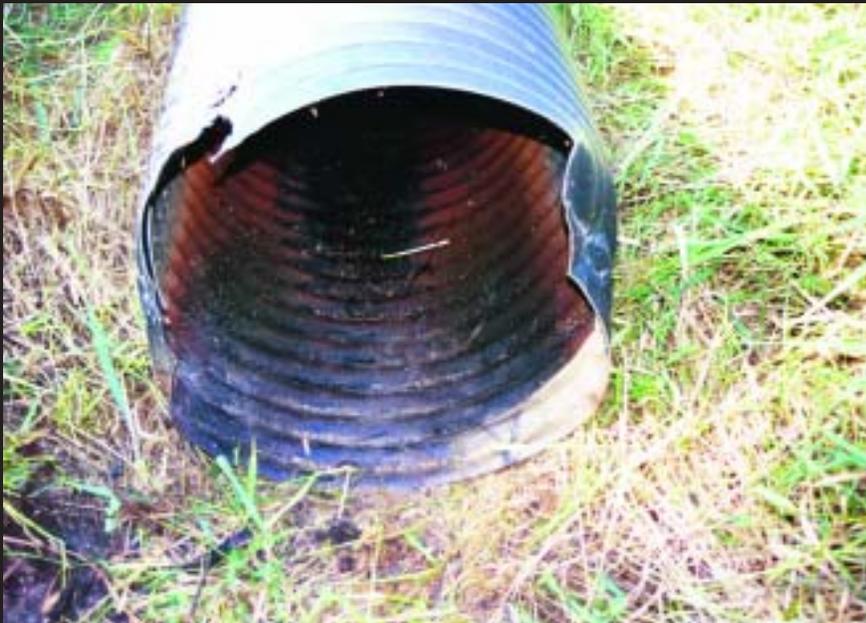
Town Hall Road. This 30-inch diameter polymer coated pipe was installed in 1974. It was approximately 27 years old at the time of the inspection. It is riveted construction installed without end sections. Thickness measurements revealed that the polymer coating was 10 mils inside and 3 mils outside. Approximately 4 feet of pipe was exposed on either end and subjected to mechanical damage. The polymer coating was tightly adherent, even at the locations of mechanical damage. Negligible lifting of the polymer was possible when picked with a knife.

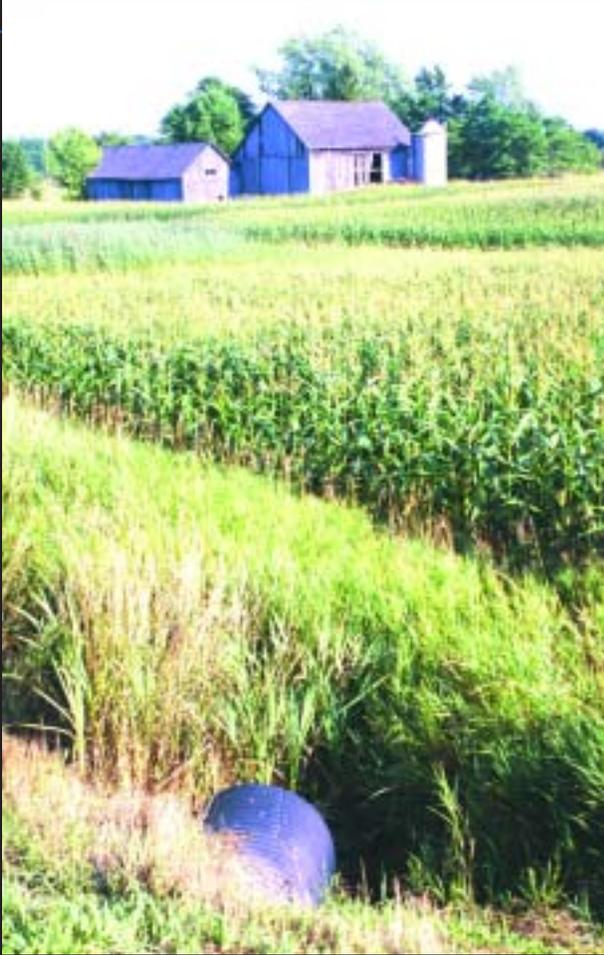
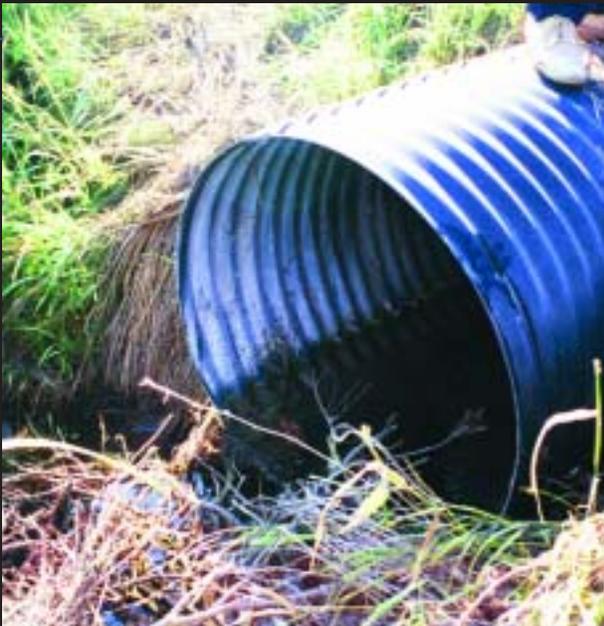
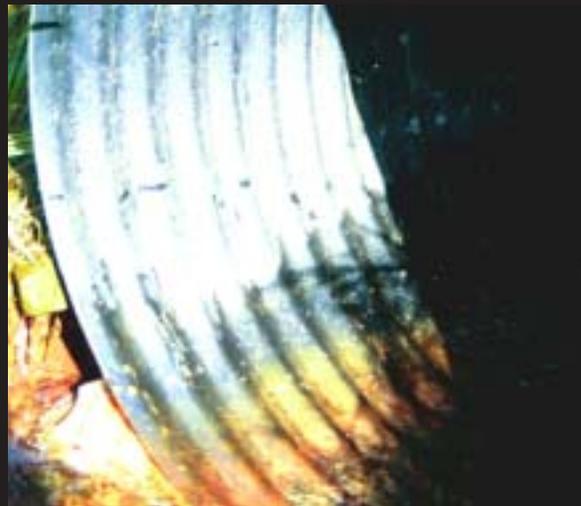
Cherneyville Road. This 36-inch diameter pipe is under a two-lane road adjacent to a cheese factory and was installed in 1977. Polymer thickness was confirmed to be nominally 10 mils inside and out. The invert was in good condition with a white, lime like material covering the invert and up the sides on the outlet end. At the inlet end, approximately $\frac{3}{4}$ inch of polymer could be lifted from the cut edge. The polymer was tightly adherent throughout the remainder of the pipe, including the outlet cut edge.

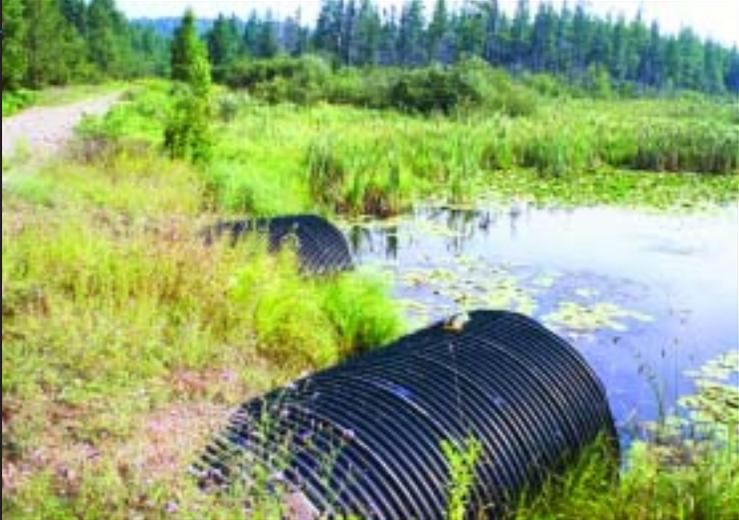
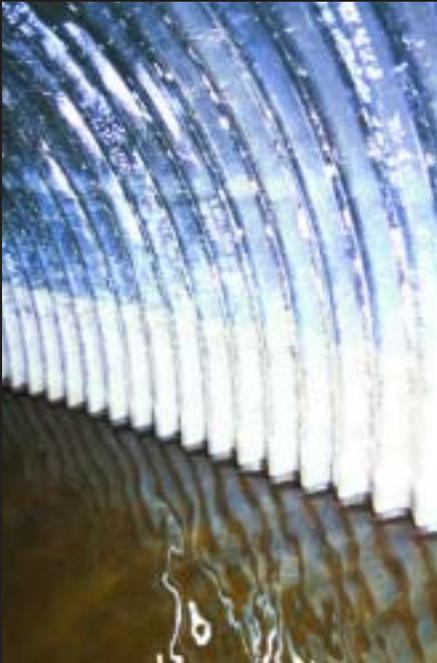
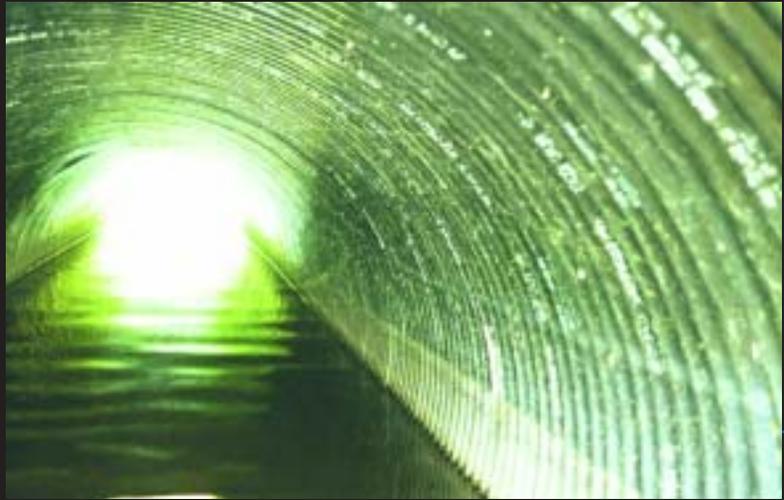
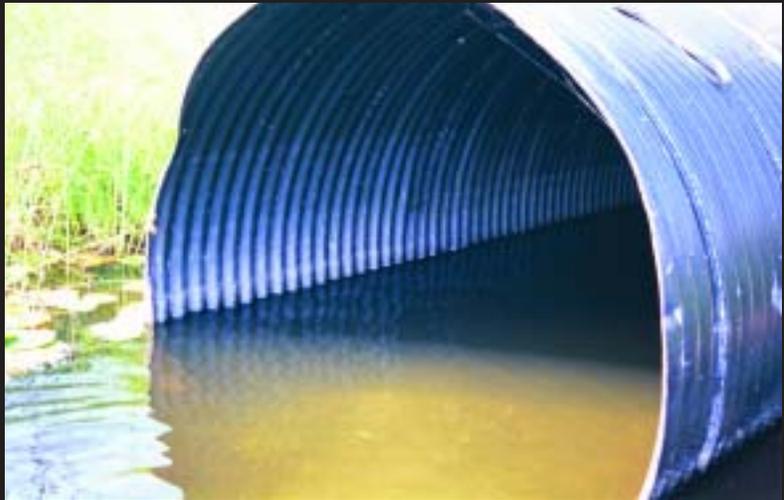
This site has two, 72-inch diameter polymer coated pipes adjacent to each other. The pipes appear to have been installed in 1984, making them 17 years old at the time of the inspection. The pipes serve as equalizers between two swampy areas underneath an abandon railroad. There were no joints in either pipe. The polymer was well bonded and in good shape over the entire length of the pipe. There was minimal polymer peeling at the cut edge—maximum of 1/8 inch underwater, 1/8 inch in “dry” areas.
